Transplantation of *Enhalus acoroides* on a sedimentary beach in Ambon Bay

To cite this article: Andi Irawan 2018 *IOP Conf. Ser.: Earth Environ. Sci.* **118** 012054

Andi Irawan¹

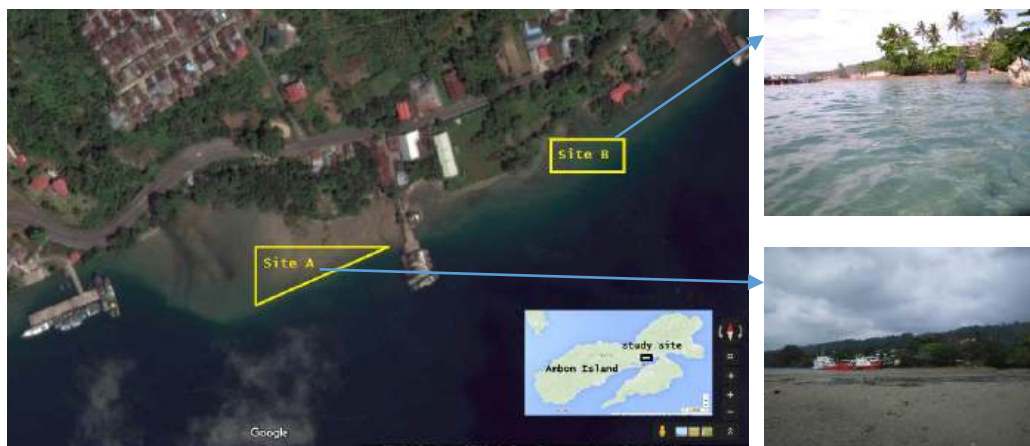
Figure 1. Seagrass transplantation site in Kate-kate Beach, Ambon. Site A has a muddy sand substrate and site B has a stony sand substrate.

The location of this seagrass transplantation was at Kate-kate Beach, which was divided into two sites (Figure 1) because the main site (A) does not have adequate area suitable for seagrass transplantation. Seagrasses are sea plants, so they need seawater for their lives. Unfortunately, the sediment in site A is so thick that makes most of the area less inundated by seawater, especially at low tide. So, another site (B) has been added to pursue 1000 m² target of this activity. Because of the limited space for transplantation, in general, there are three location's characters in each site (regarding their condition at low tide), which are dry/exposed area, wet/muddy/shallow area and deep/submerged area. This difference gives us an opportunity to evaluate the survival rate of the transplant in each area.

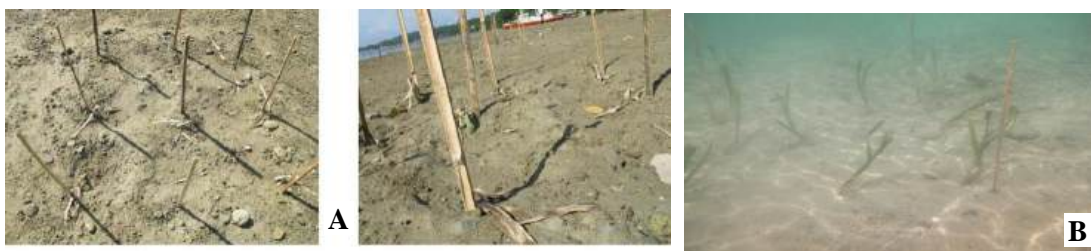
Figure 3. Transplant condition in the first month after transplantation: A= in dry and muddy area, B = in submerged area.

In the first month after transplantation, the general result could already been seen. Almost all the transplants grown in exposed area became dry and die (Figure 3A). In the wet/muddy area, their leaves became dry but the buried organs such as roots, rhizomes and leaf sheaths were still fresh in some transplants. On the other hand, the transplants in submerged still survived (Figure 3B). The condition where *Enhalus acoroides* transplants were more likely to survive in submerged location could be related to this species's habitat preference. On the other study of seagrasses in this bay, it was found that distribution and abundance of this species was related to salinity and depth [11]. In other word, this species prefers to live in deeper or submerged location.
